Appendix F
Cultural Resources

Appendix F-1
Draft LOR

DRAFT
LETTER OF RESOLUTION
AMONG
THE FRANCHISE OVERSIGHT BOARD,
THE NEW YORK STATE OFFICE OF GENERAL SERVICES,
THE NEW YORK STATE OFFICE OF PARKS, RECREATION AND HISTORIC
PRESERVATION (NYSOPRHP),
AND
THE NEW YORK RACING ASSOCIATION
REGARDING
THE SARATOGA RACE COURSE REDEVELOPMENT PROJECT
SARATOGA SPRINGS, SARATOGA COUNTY

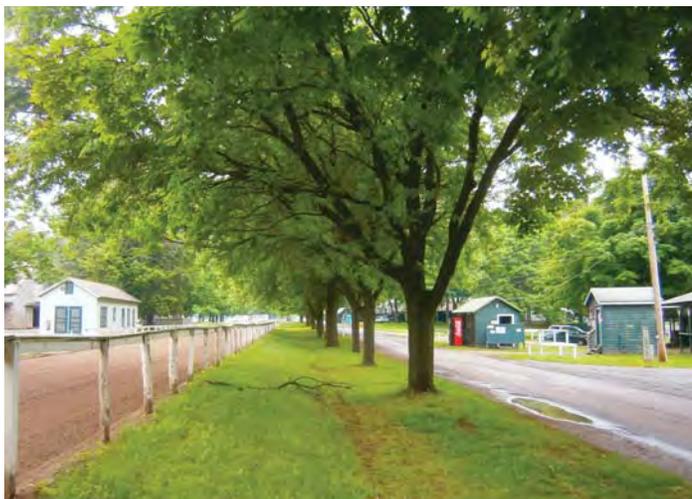
Typical roadway allee planting

character of the campus. In particular the plan determined that the Course contains four basic concepts for tree plantings: boulevard planting, roadway planting, barn allees, and stabling area groves. These basic concepts provided the framework for the proposed plantings within the subareas of the Backstretch.

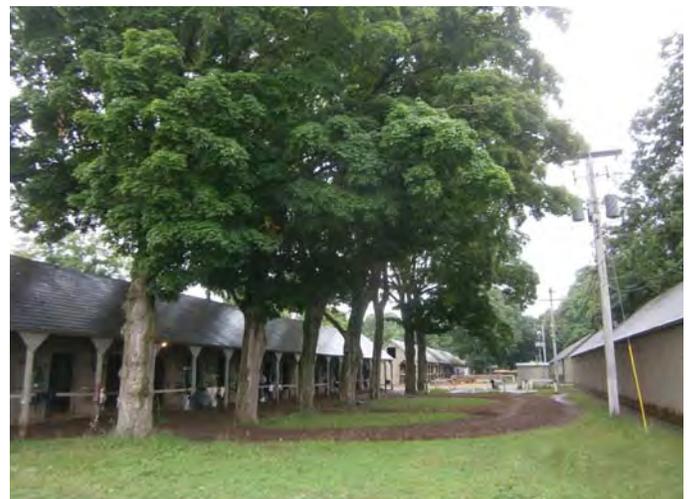
Typical barn allee planting scheme

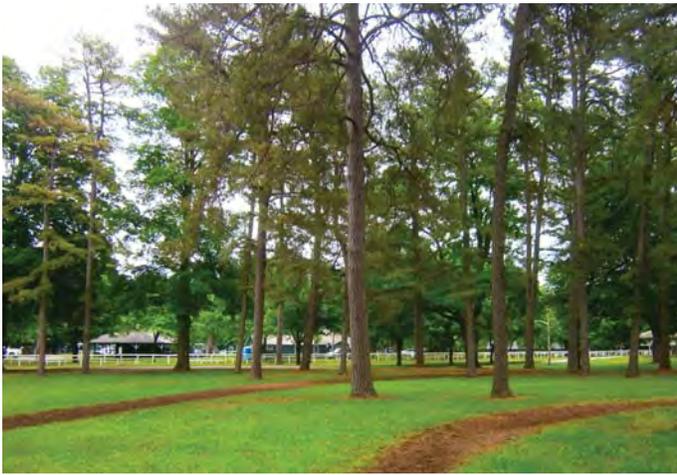
Stabling area grove planting

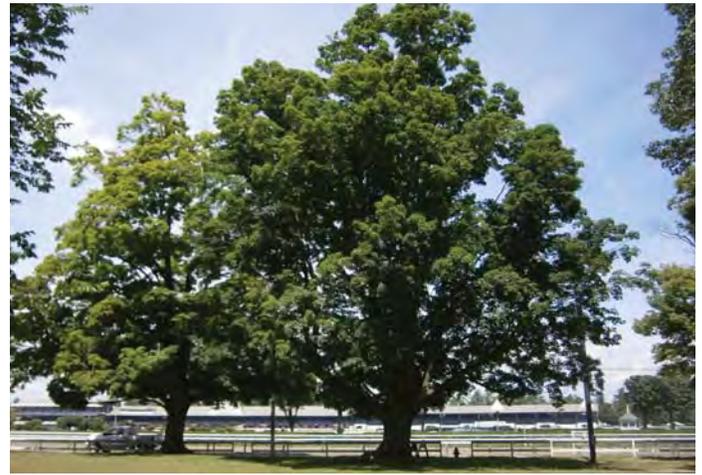
Typical large diameter “heritage” Maples found on site

The site predominantly consists of many large diameter Sugar Maples, White Pines and Pitch Pines with some very impressive Oaks as well. The heritage Sugar Maples are an attractive tree and the uniform planting creates a sense of order and tranquility, giving a cohesive influence to the site. Sugar Maples are

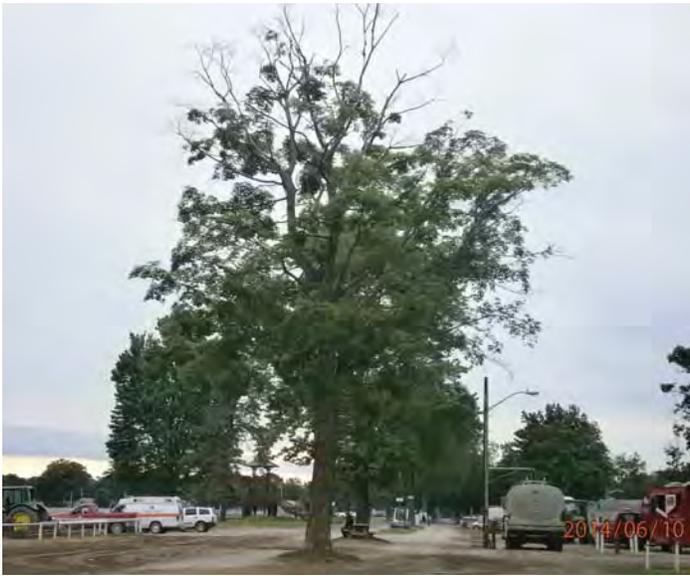
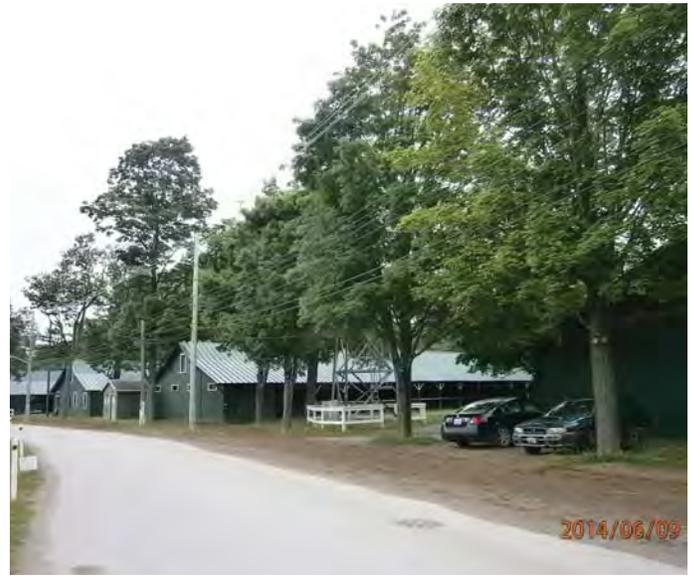
Typical “urban” conditions of the Backstretch that cause stress for the tree plantings

The Racecourse landscape, while located in a pastoral setting, inhabits an urban ecosystem. Trucks, maintenance vehicles, cars, horses and people moving through the site compact the soil and emit carbon monoxide. Because of these factors, the tree recommendations must be tolerant of urban conditions but must also provide the height and massing required to maintain the Course’s historic landscape character.

not typically tolerant of difficult urban conditions, however, the unusually deep sandy soils present on site have been favorable to the Maple plantings. Even so, the Maples are in various states of decline and there is a practical need for species diversity to ensure the attractiveness and longevity of the campus landscape for years to come. With this understanding, a comprehensive program of pruning, fertilization, removal, and new plantings is recommended.

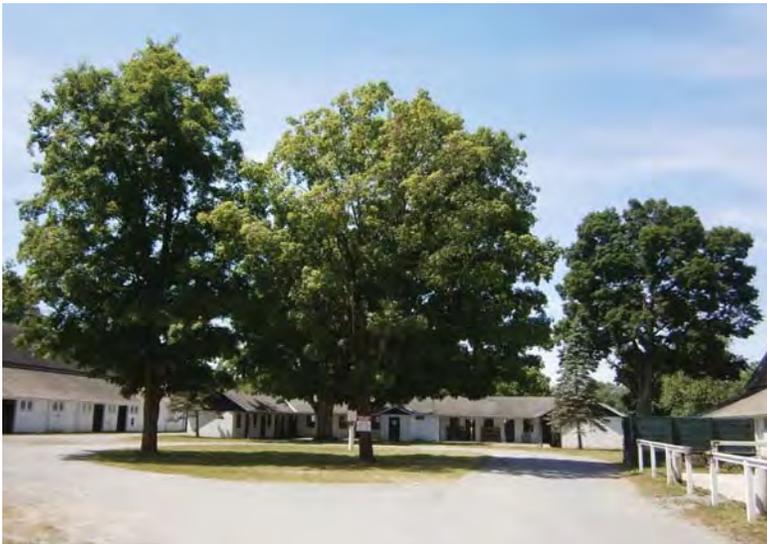
Sugar Maples in the Sanford area of the Backstretch

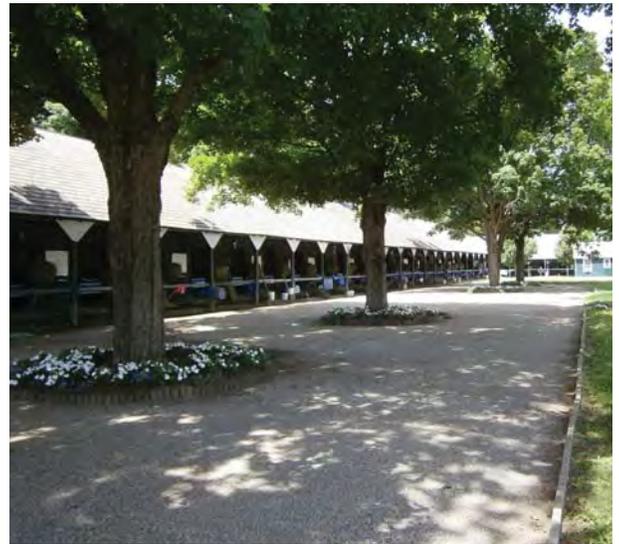
Stabling area near the Oklahoma Track

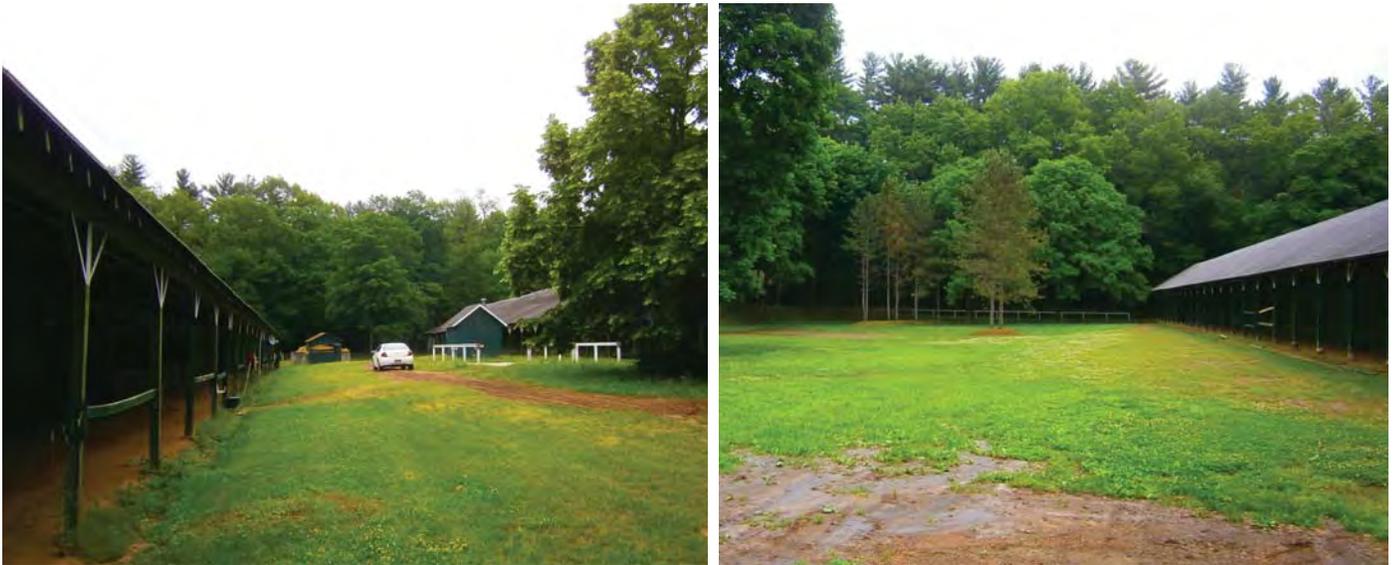
Typical stabling areas in need of shade tree plantings

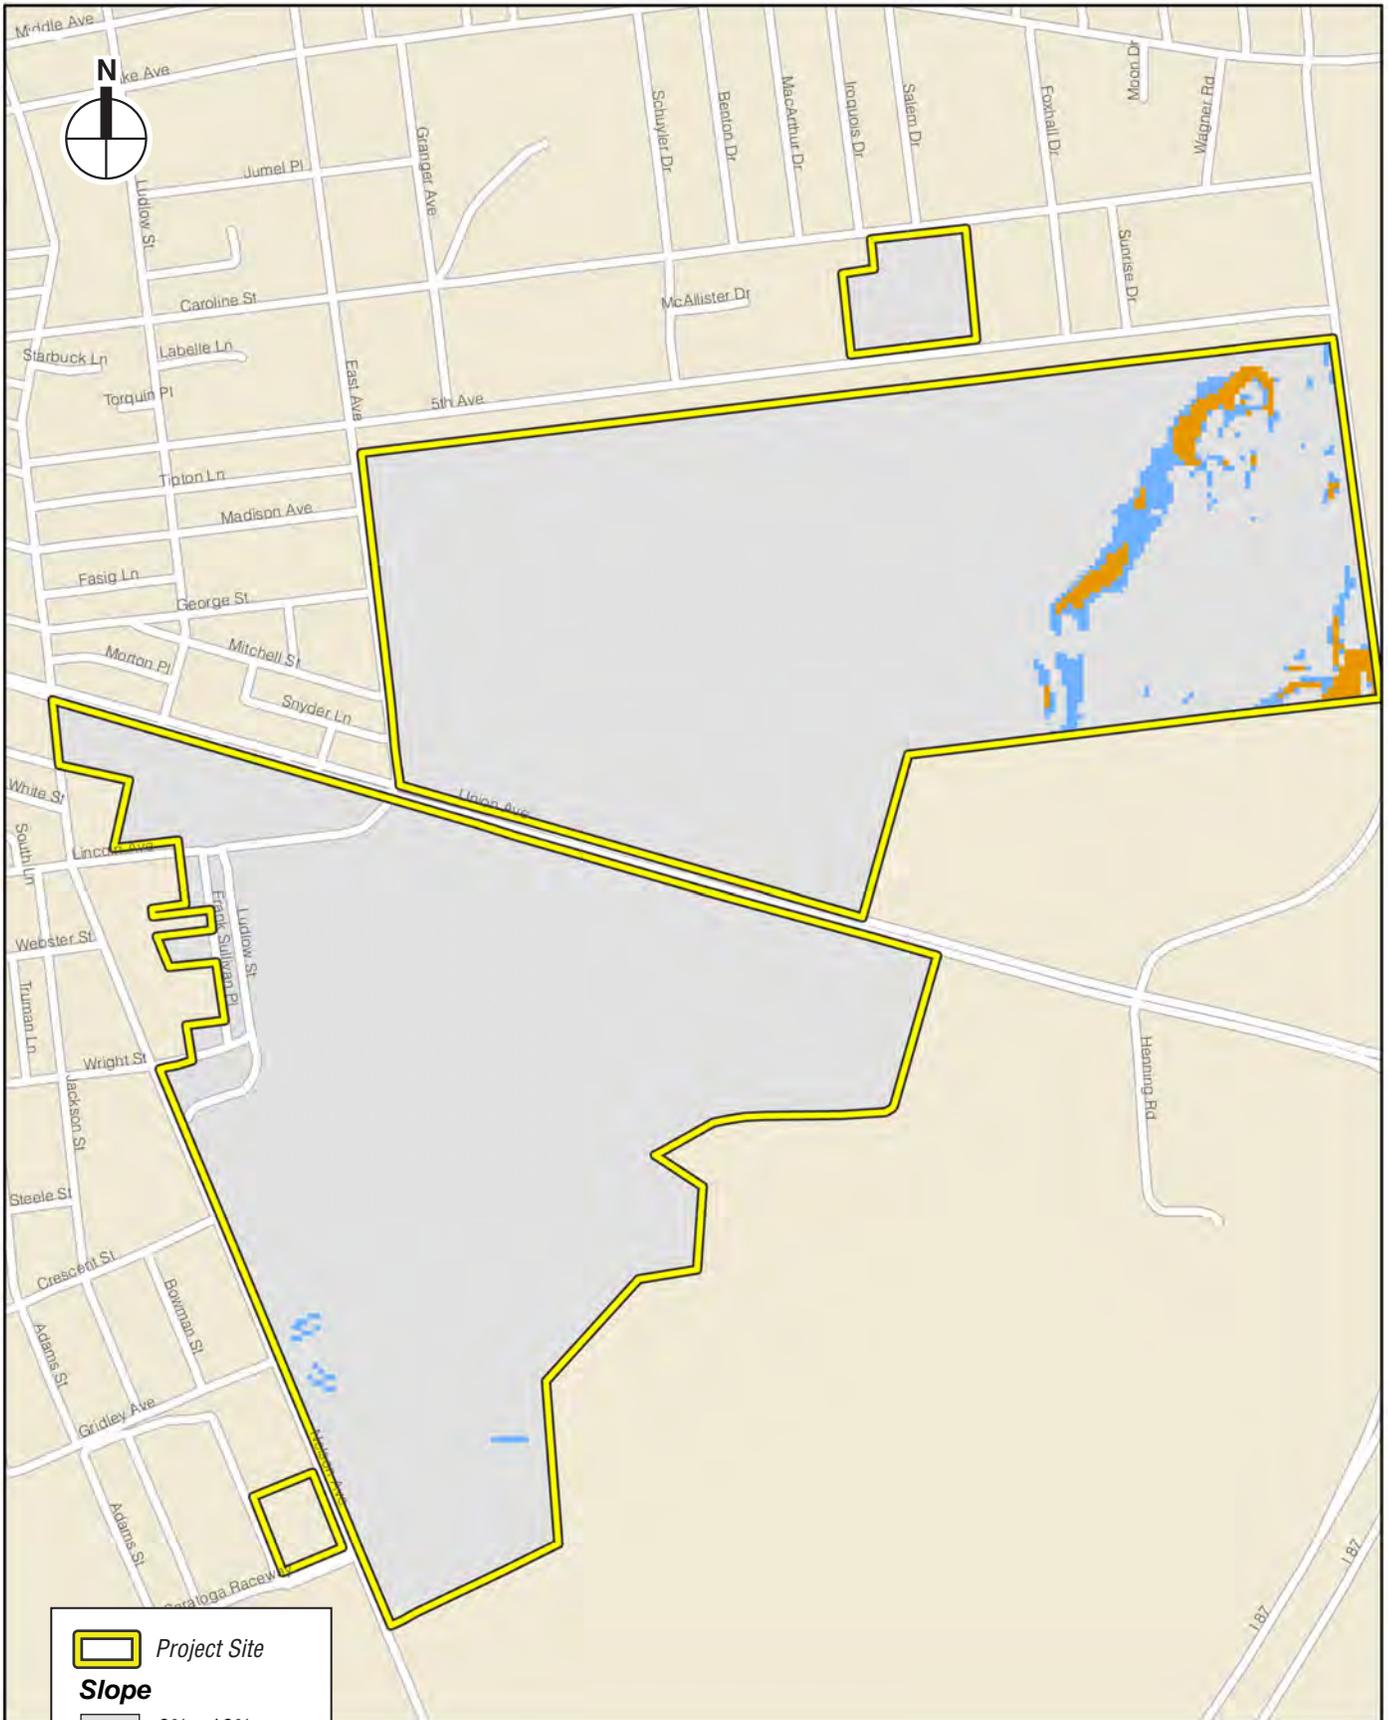
Onsite Slopes
Figure 3

Slope

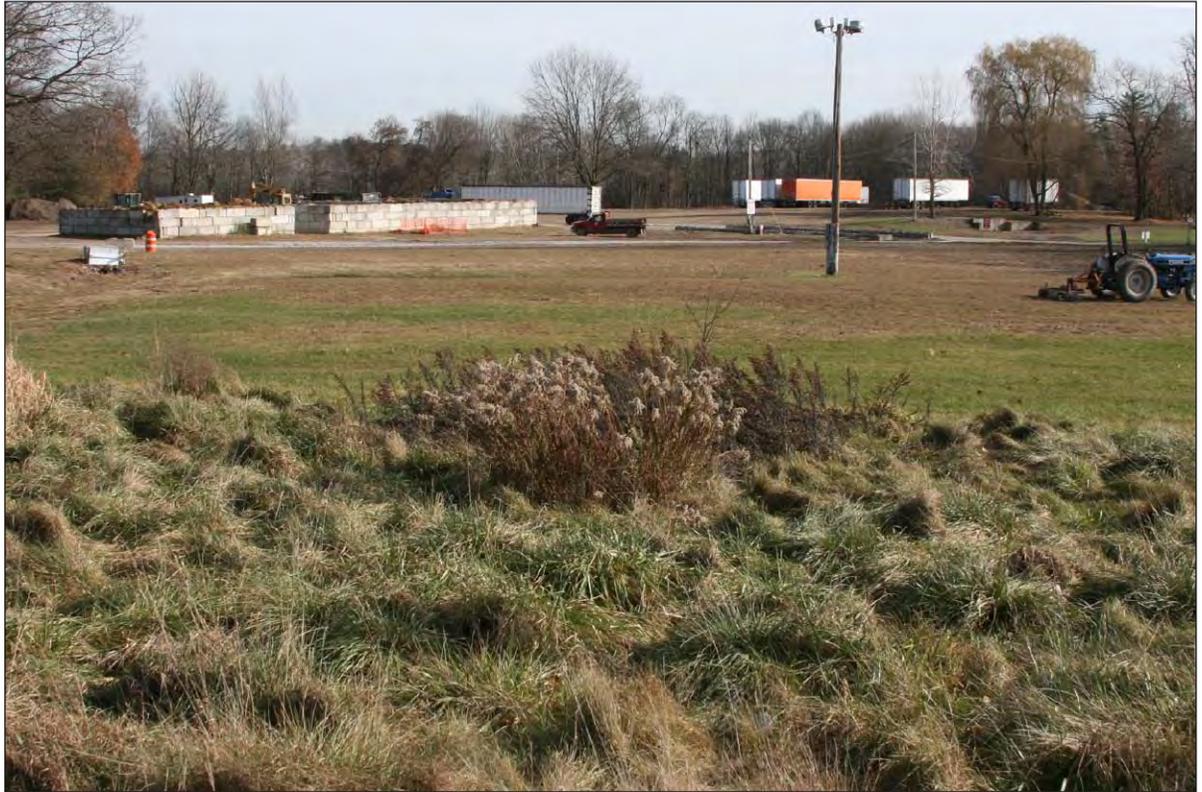
2

A view of the Lowlands area, looking east from the western portion of that area. The majority of this maintenance area has been cleared and extensively graded. Soil piles and concrete block containers are located here, and containers are stored here **3**

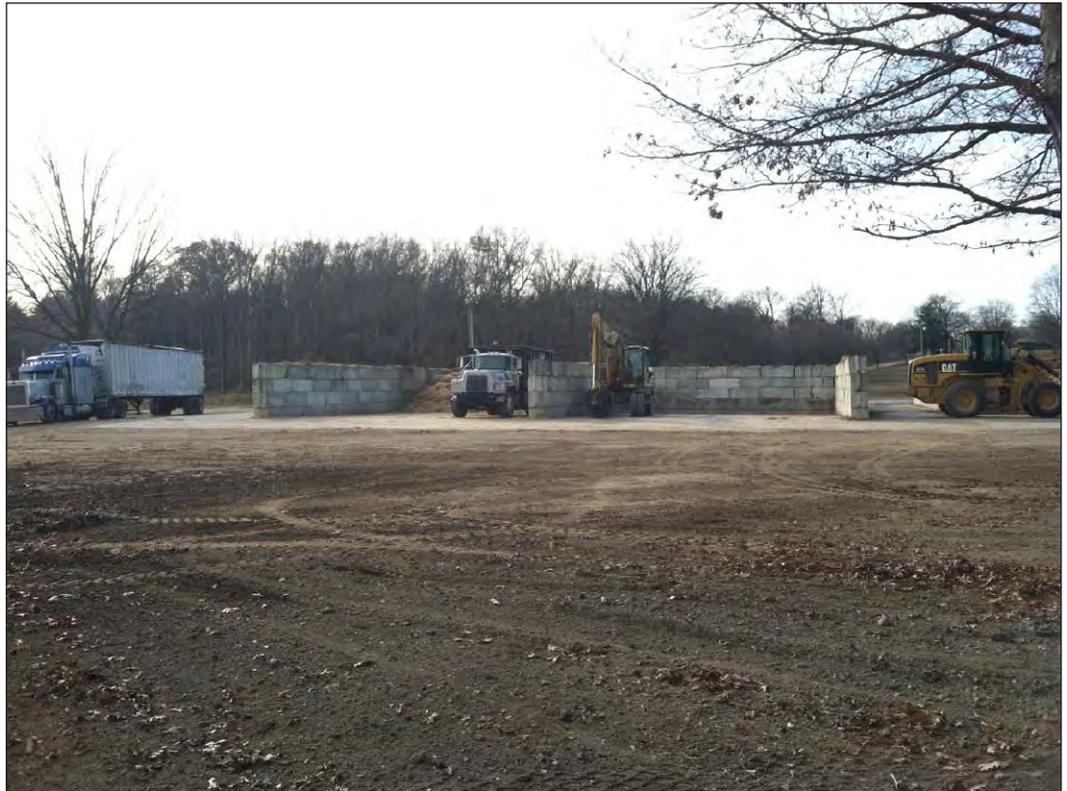
The Lowlands area appears to be extensively disturbed through grading and movement of materials. Concrete pads and concrete block bays are shown here which accommodate storage of materials such as soil. There is heavy truck traffic throughout much of the cleared area **4**

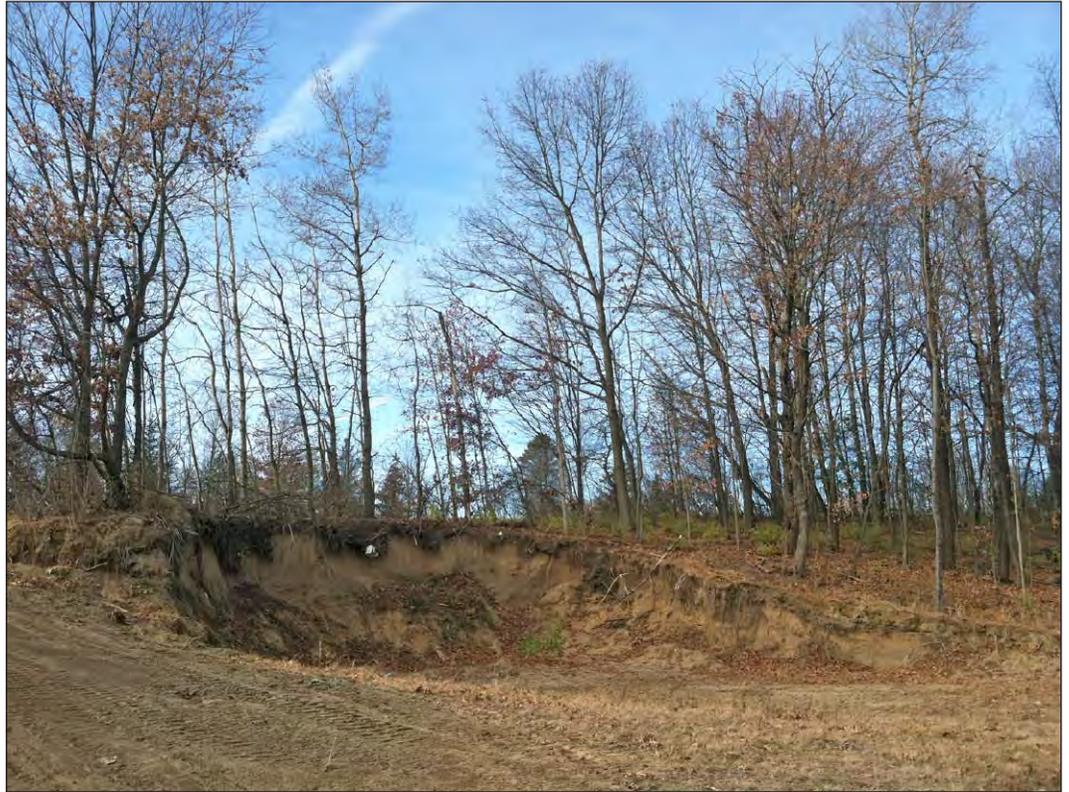
Within the Lowlands, there are areas of relatively steep slope, otherwise an anomaly on the Race Course landscape. There is also evidence of soil mining and cutting **5**

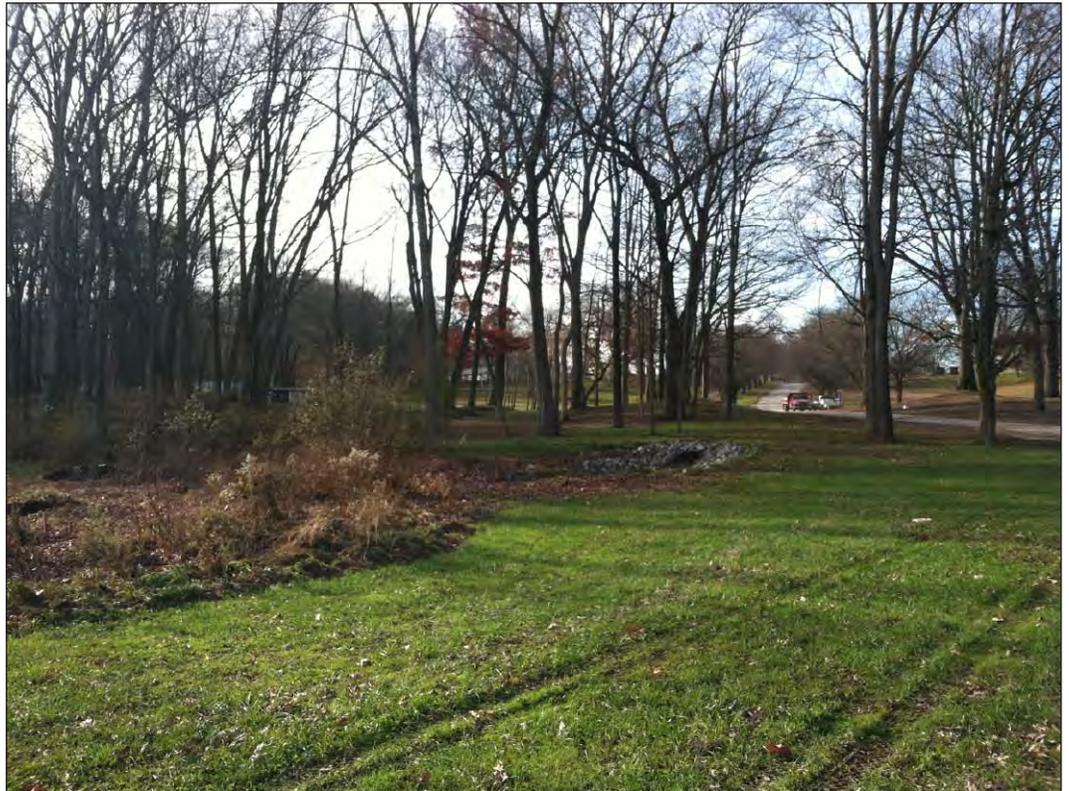
Looking west from within the Lowlands area, this view shows the wetland mitigation area (a recently created wetland) on the left. A storm drainage system is visible at center **6**

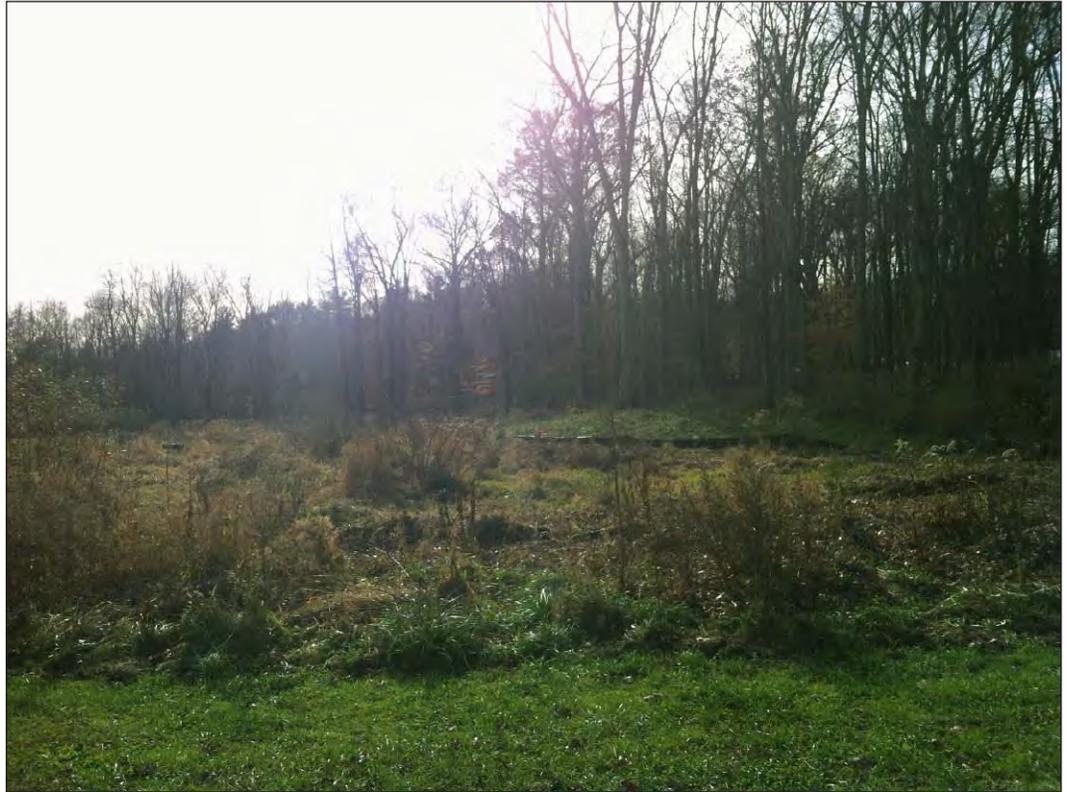
Looking east within the Lowlands area, the wetland mitigation area is shown in the foreground. The wooded fringe visible beyond is undeveloped and may include soils that have not been disturbed by Race Course development

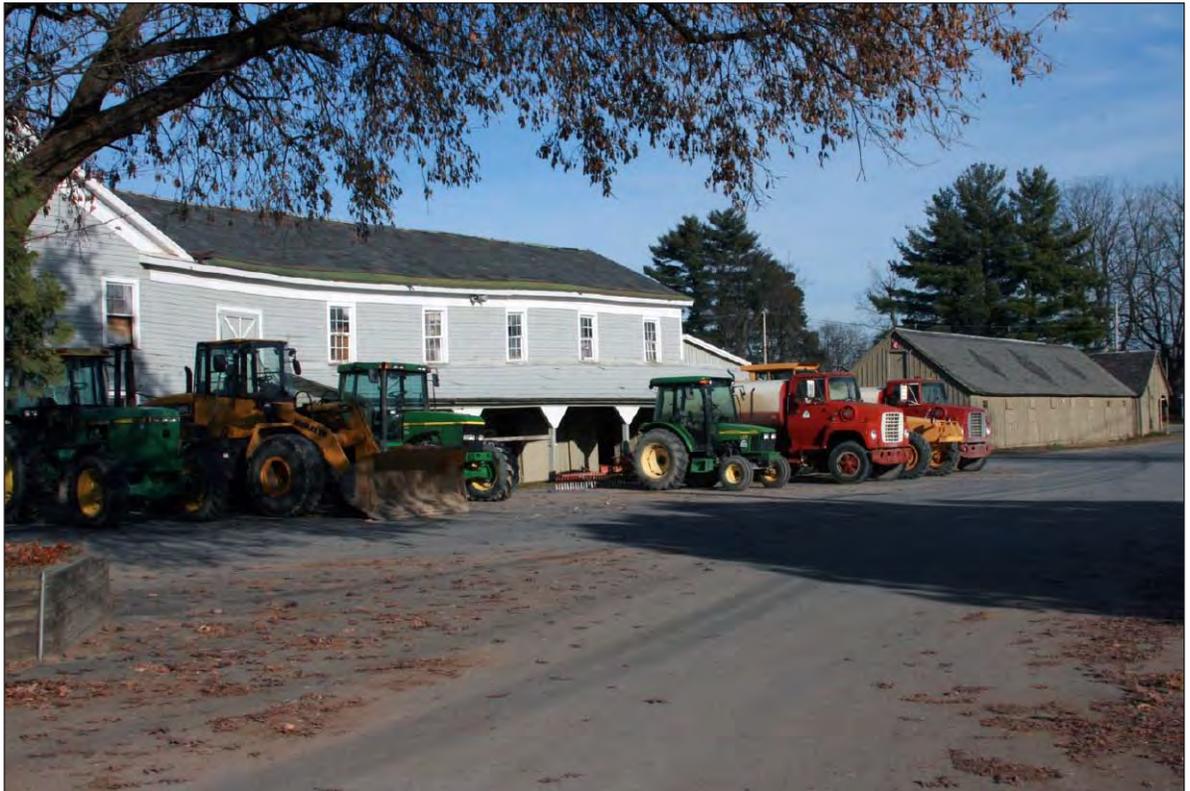
The Horse Haven section of the Backstretch comprises the original Race Course property and retains several buildings dating to the earliest period of the Race Course, from the 1840s to the 1860s. This view looks southeast towards Building 76 and Barn 45

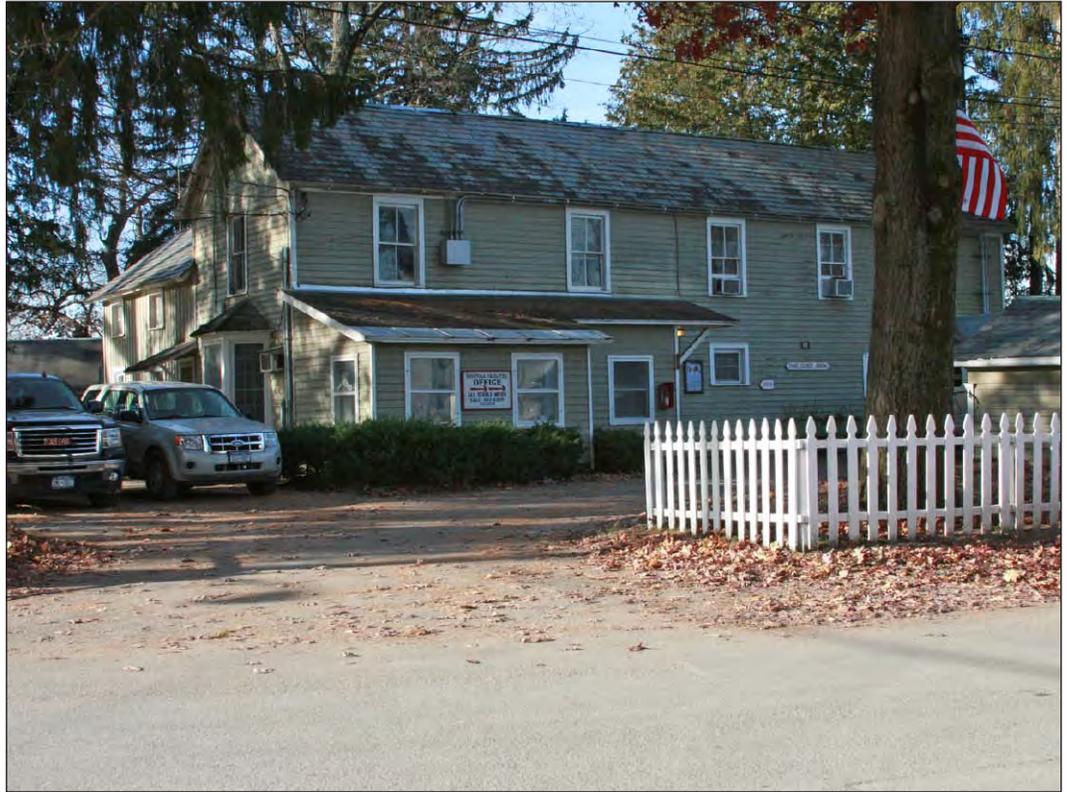
Building 68 within the Horse Haven section of the Backstretch has been identified as a former residence constructed during the earliest period of the Race Course

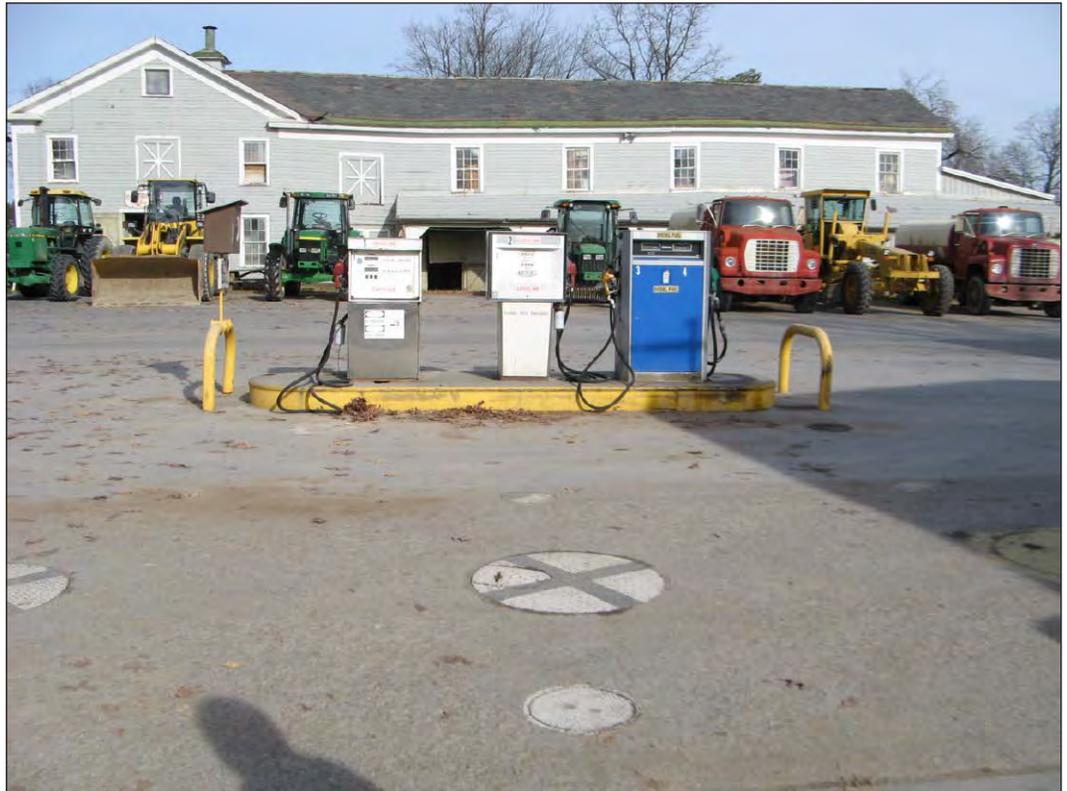
A view of the fueling station and concrete areas between Buildings 71 and 76 in the Horse Haven section of the Backstretch

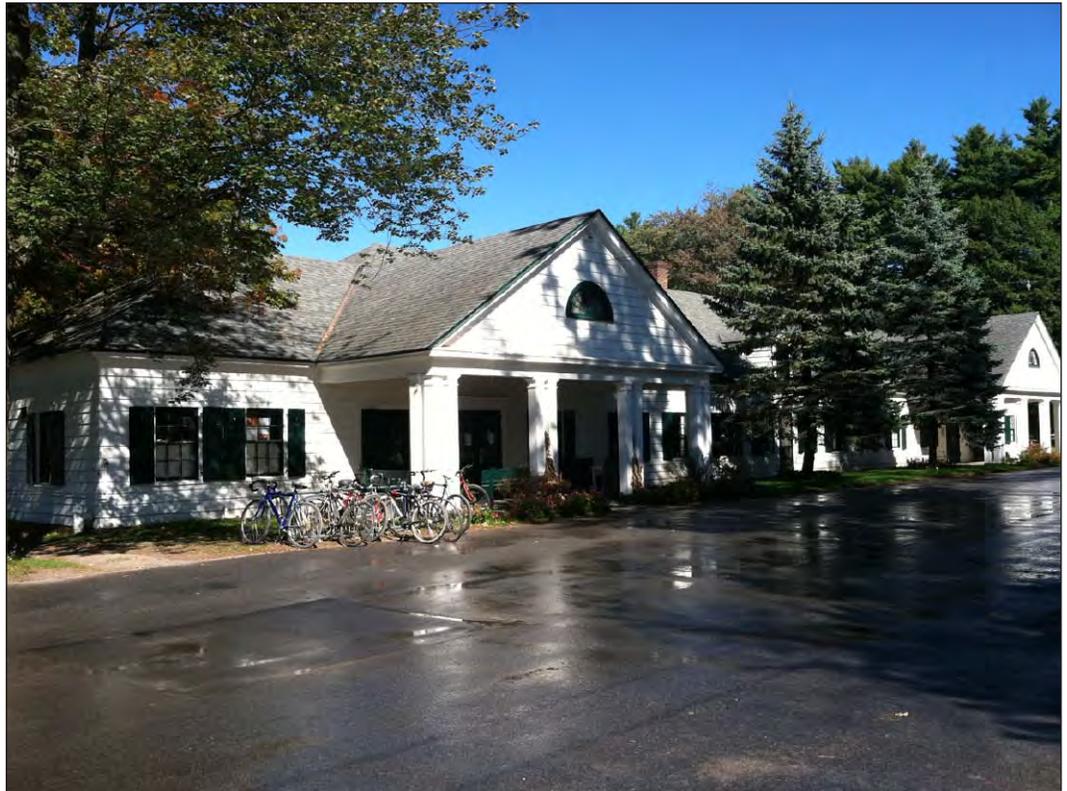
The Recreation Unit within the Backstretch is a Neoclassical gymnasium likely constructed in the 1920s

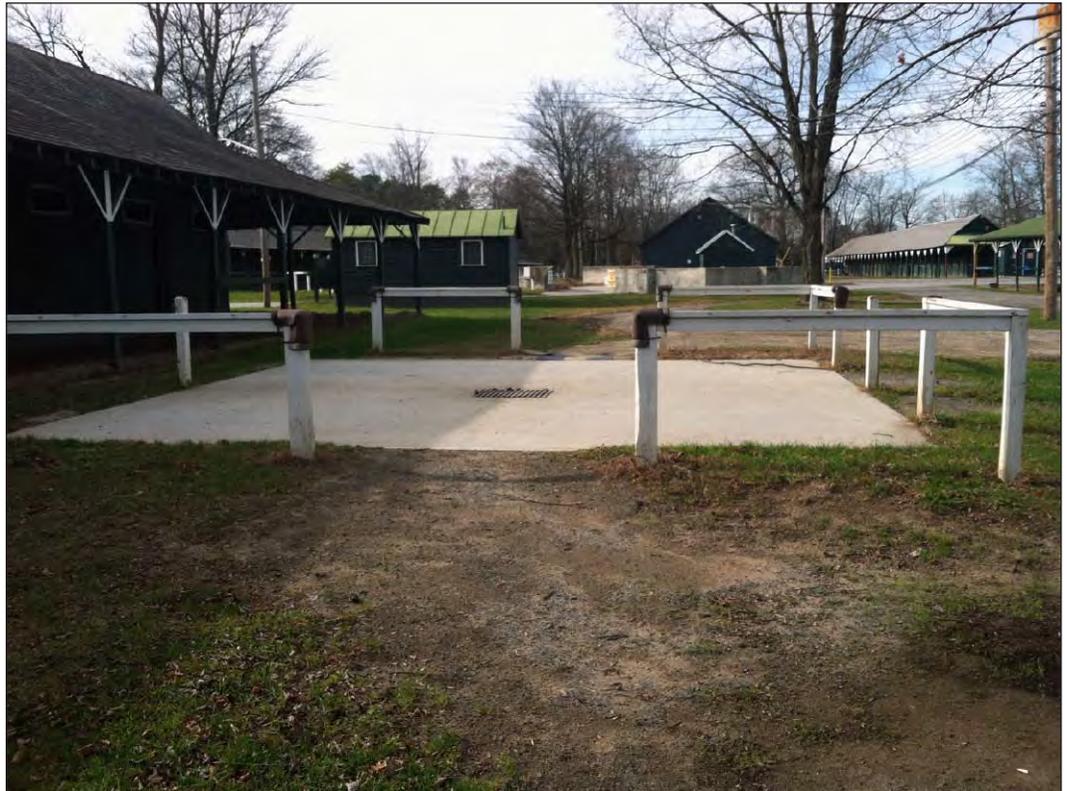
A subarea within the Race Course's Backstretch, also known as the "Backstretch" contains barns and bunkhouses dating to the early 20th century. This view, looking west from the north side of Barn 17, shows the concrete wash pads that are found throughout the larger Race Course Backstretch. A concrete straw storage structure is also visible in the background **14**

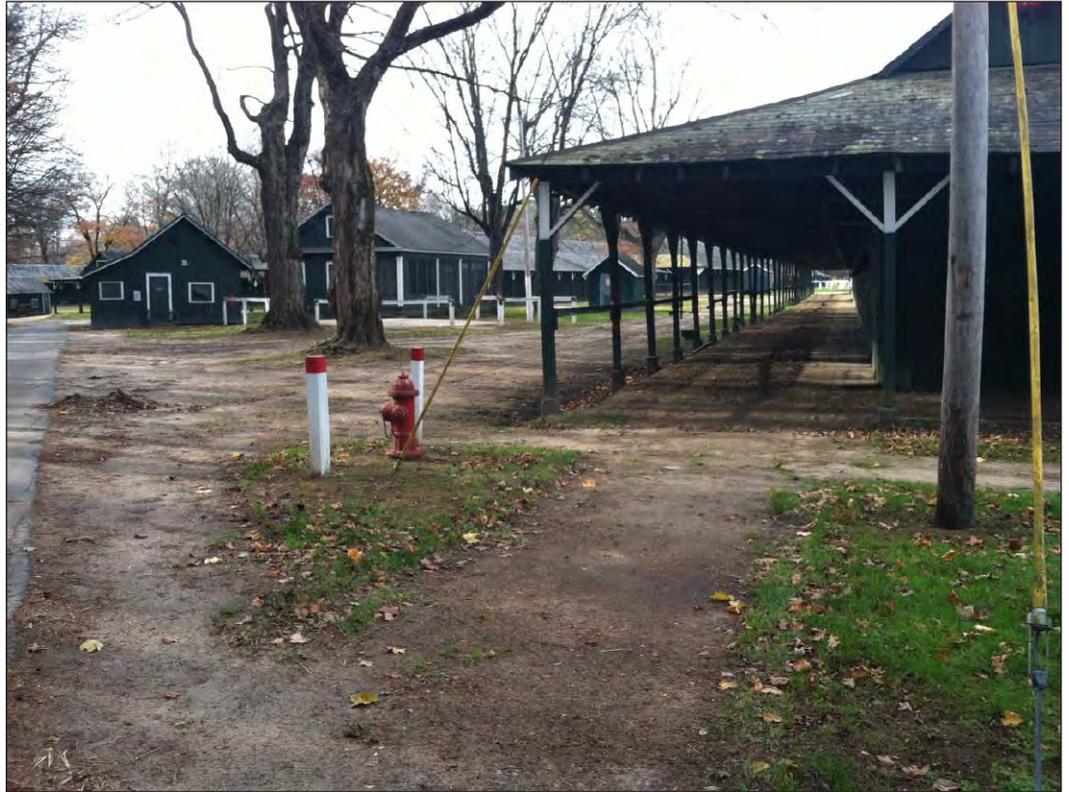
15

Within the Backstretch subarea, this view looking southwest from Barn 17, shows the combination of paved roadways and dirt paths common throughout the Backstretch. A fire hydrant is visible in the foreground

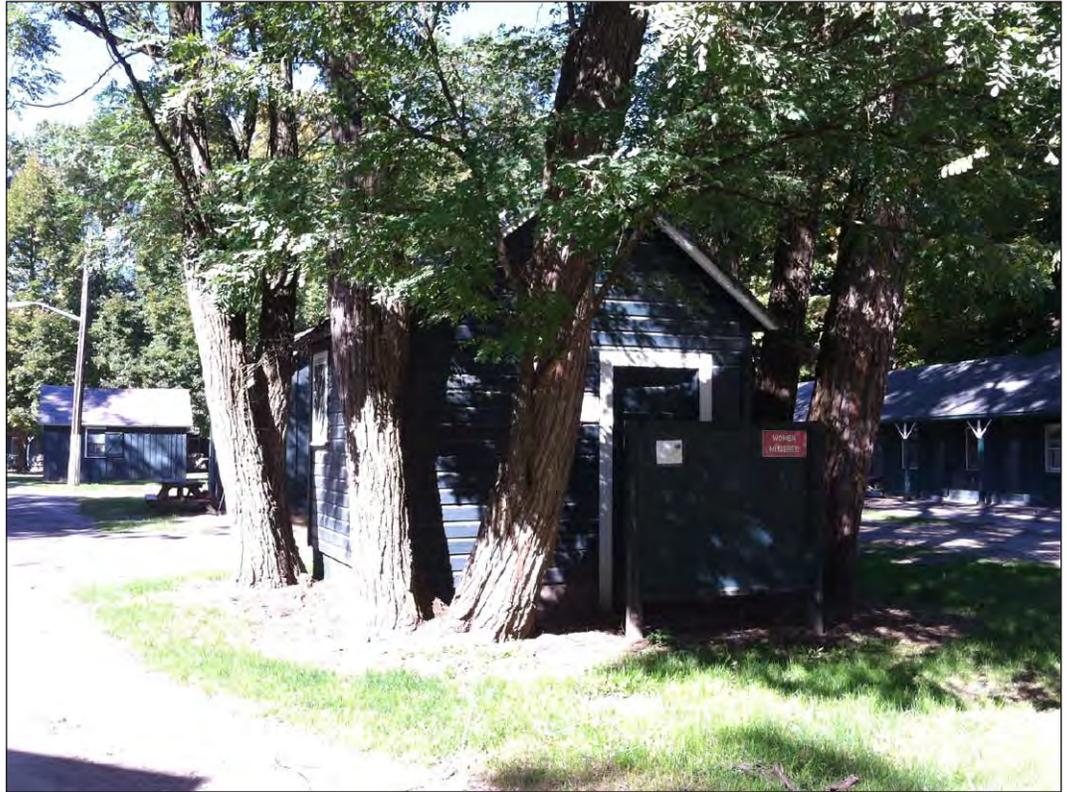
This view of the Madden Court subarea, shows a small building now a restroom (Building 37T) surrounded by trees and surrounded by dirt paths and barns and bunkhouses, most of which were built in the early 20th century **17**

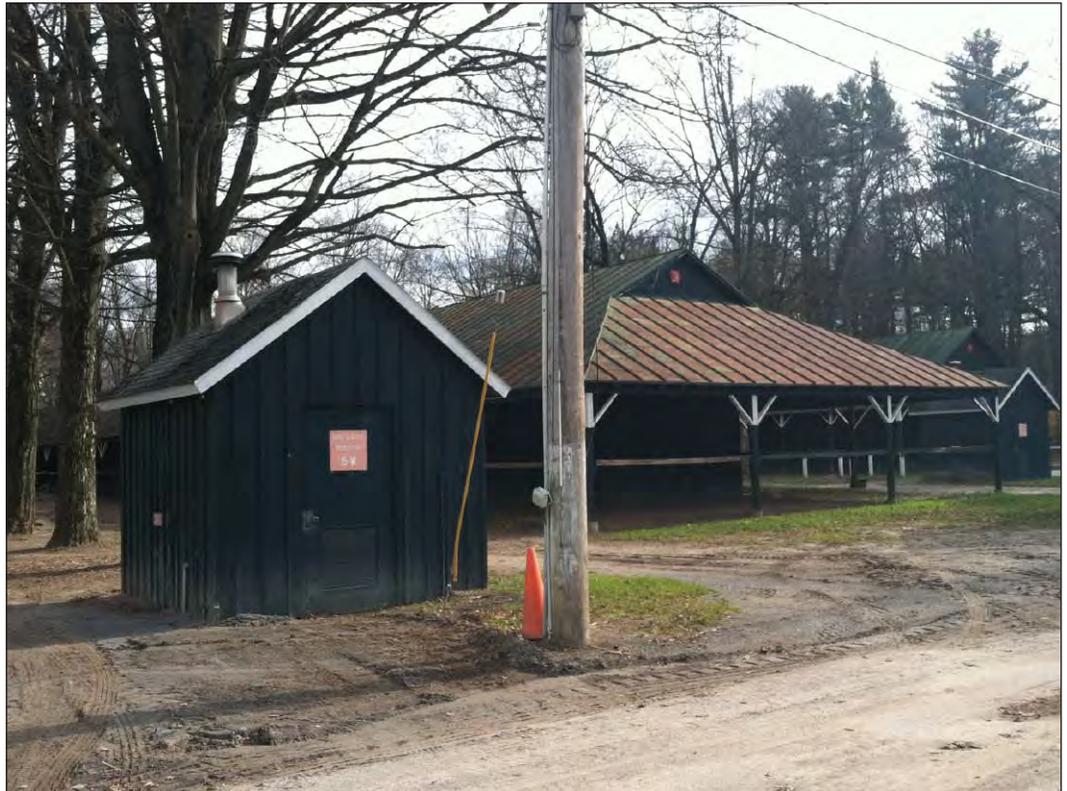
Within the Madden Court subarea, a view looking southeast towards Barn 24. Overhead utility lines are visible in the foreground. A small "hot water building" is shown in the foreground to the left of the utility pole **18**

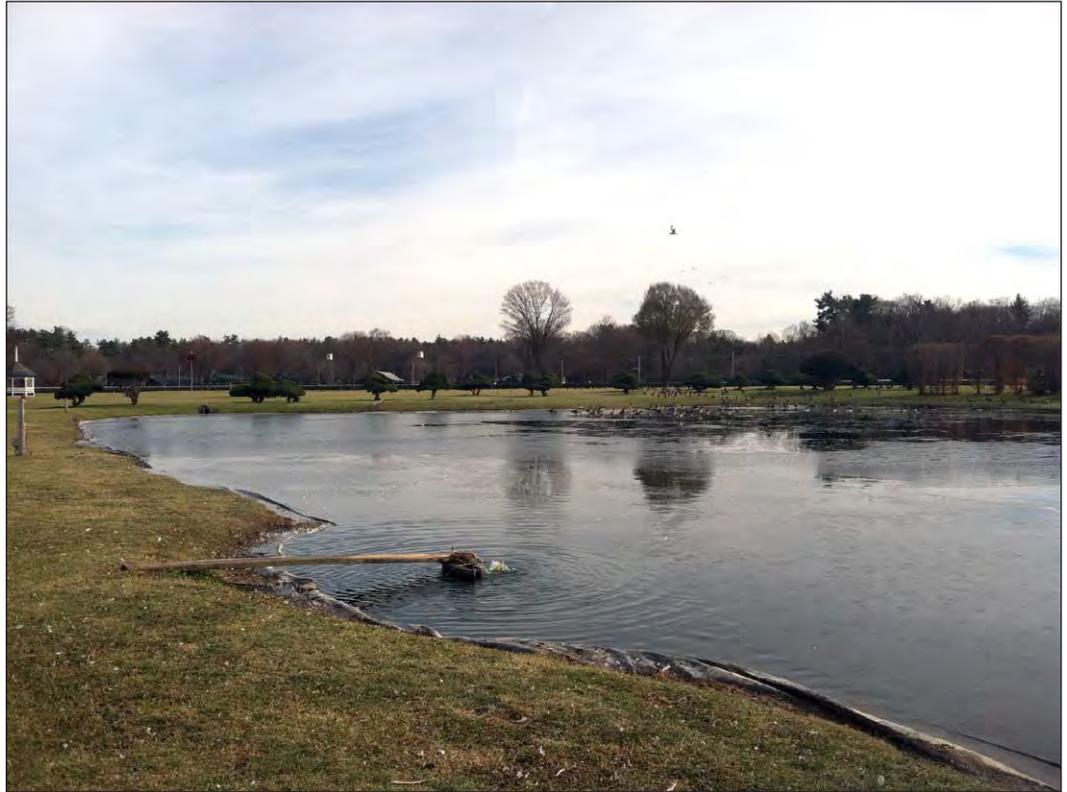
Within the infield of the Main Race Course, this view looks southeast across the infield pond, which was created in the first half of the 20th century **21**

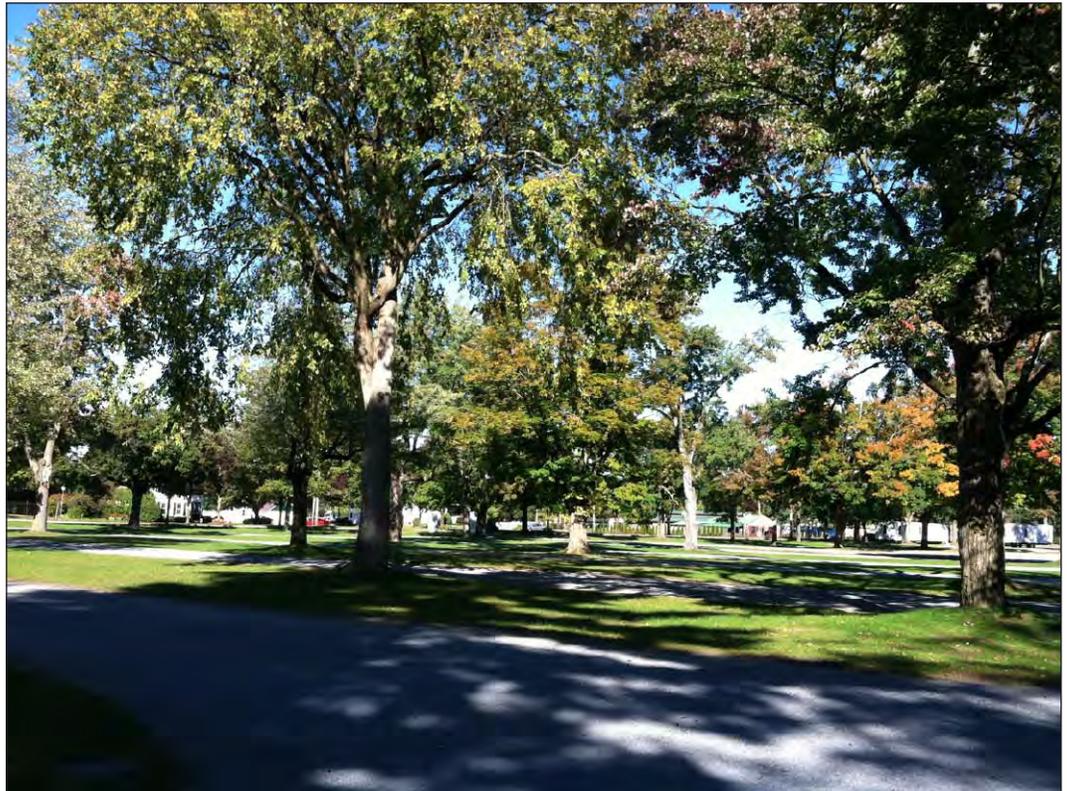
Looking north to the Autopark Area, a historic parking area composed of gravel strips, grassy strips, and mature **24**
trees. This was developed as a parking area in the 1920s and continues to serve this function

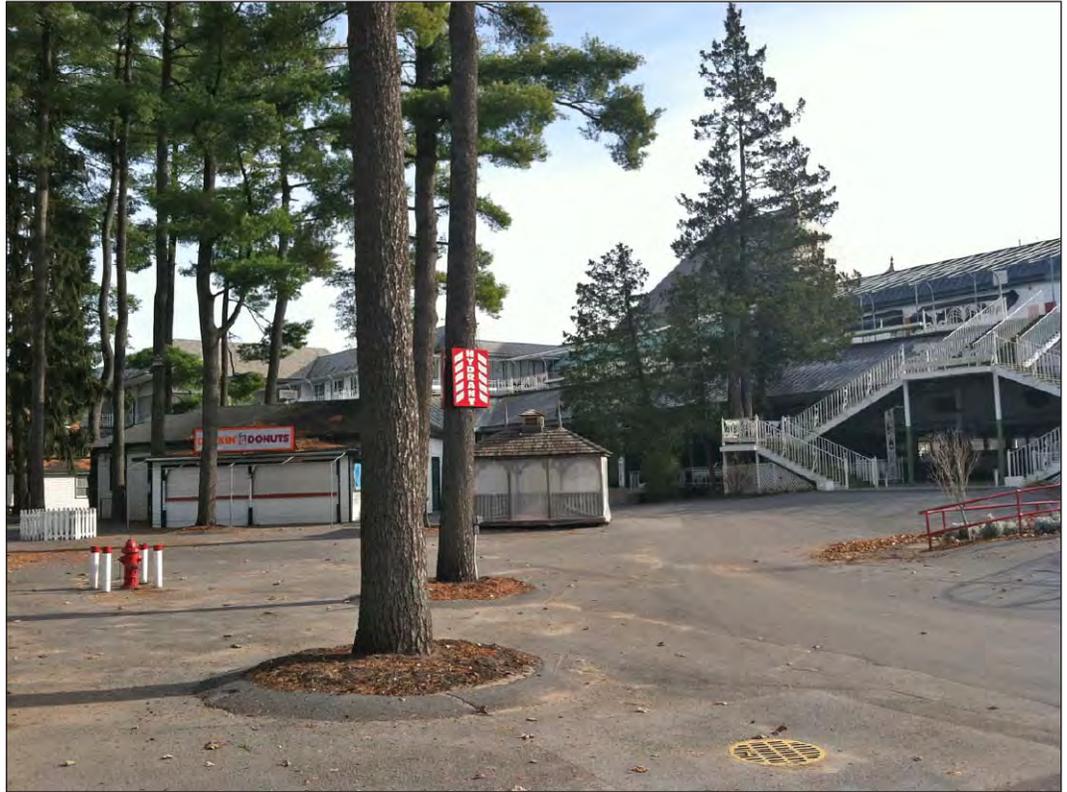
Looking northeast, a view showing the front façade of the Granstand/ Clubhouse complex, one of the most iconic constructs within the Race Course, the core of which was built ca. 1892. The paved track apron is also shown in the foreground **28**

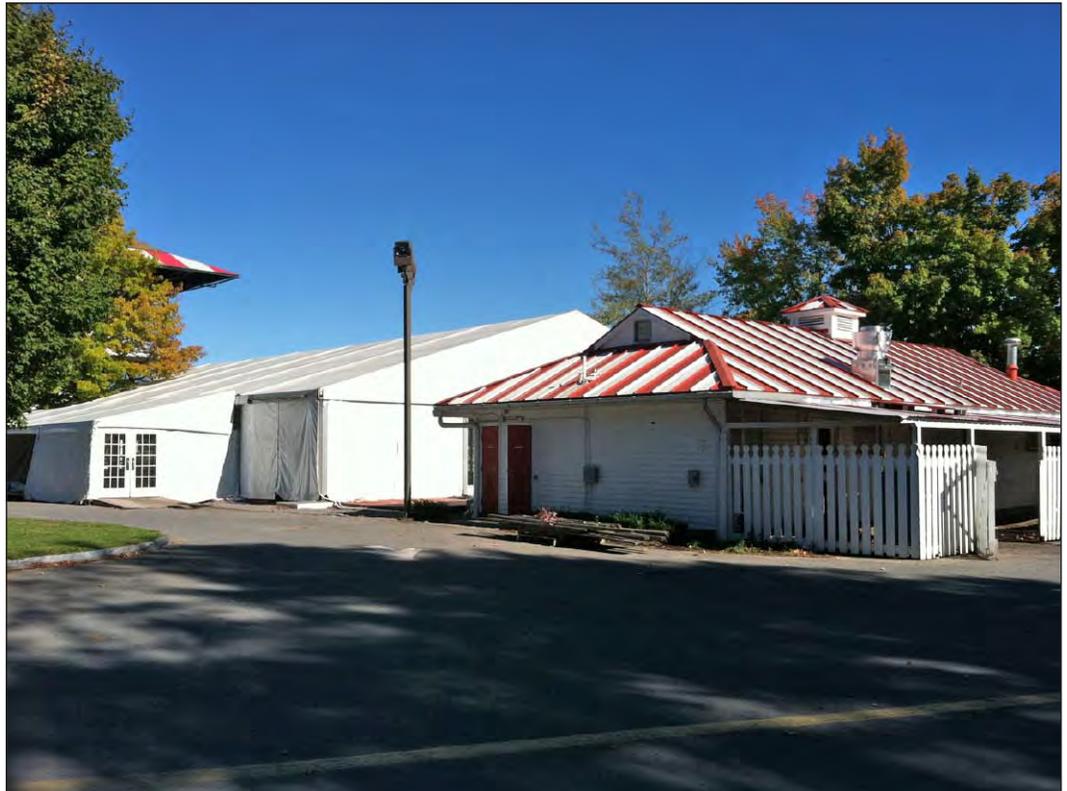
A view of the rear (north) elevation of the Granstand/ Clubhouse complex 29

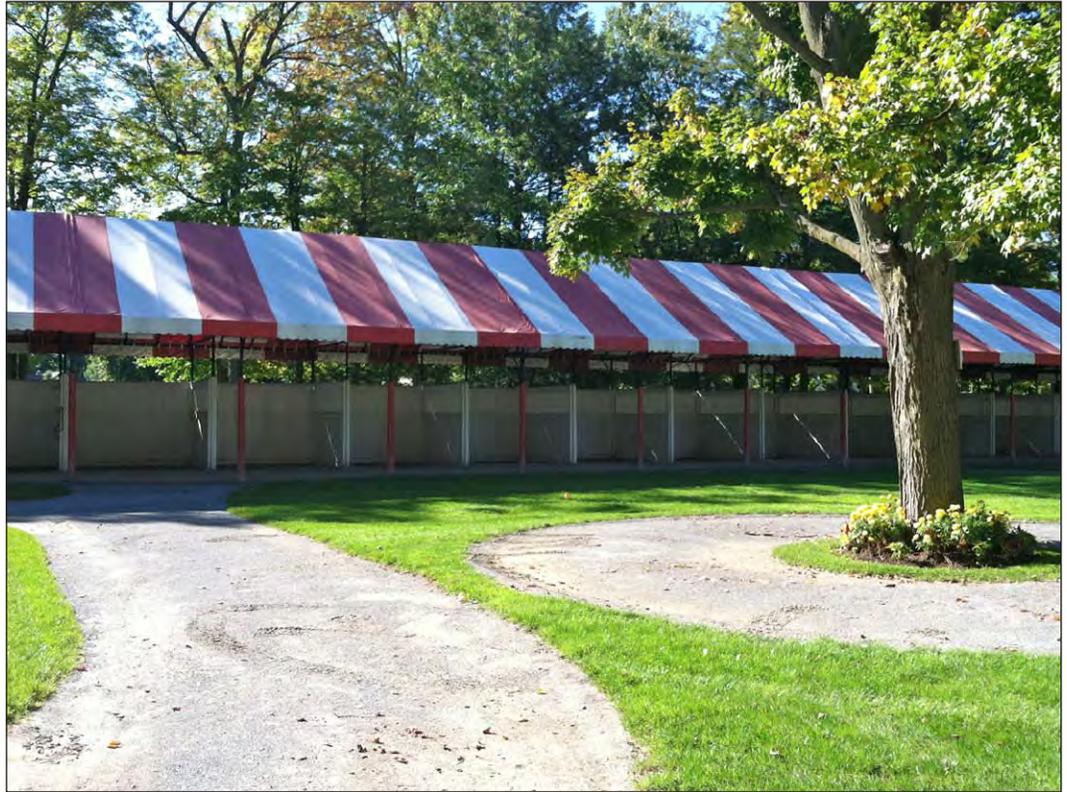
Within the Paddock & Saddling Area in the Race Course's Frontside, the Red Spring Pavilion is a mid-19th century frame pavilion that was moved to this site from another spring in Saratoga. The Big Red Spring is located beneath its current location **32**
