Appendix F
Cultural Resources

Appendix F-1
Draft LOR

DRAFT
LETTER OF RESOLUTION
AMONG
THE FRANCHISE OVERSIGHT BOARD,
THE NEW YORK STATE OFFICE OF GENERAL SERVICES,
THE NEW YORK STATE OFFICE OF PARKS, RECREATION AND HISTORIC
PRESERVATION (NYSOPRHP),
AND
THE NEW YORK RACING ASSOCIATION
REGARDING
THE SARATOGA RACE COURSE REDEVELOPMENT PROJECT
SARATOGA SPRINGS, SARATOGA COUNTY

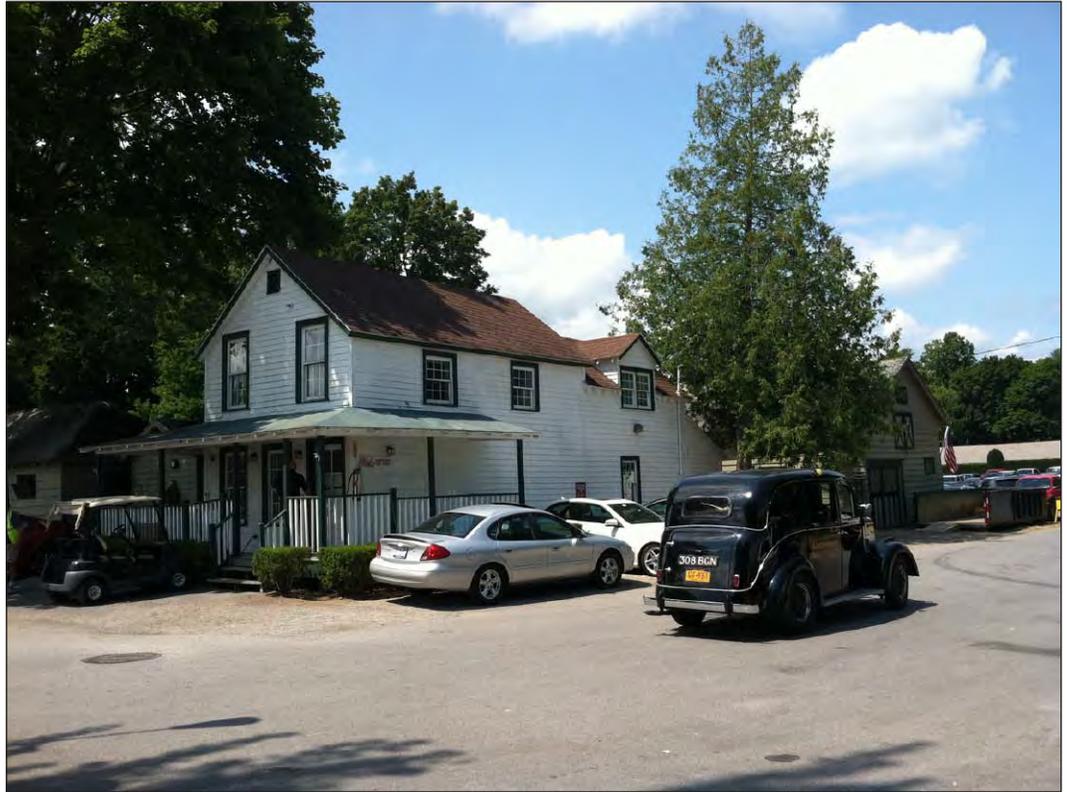
Within the Paddock & Saddling Area, the core of the Jockey House was likely constructed ca. 1900; it has received many additions over the course of the 20th century 34

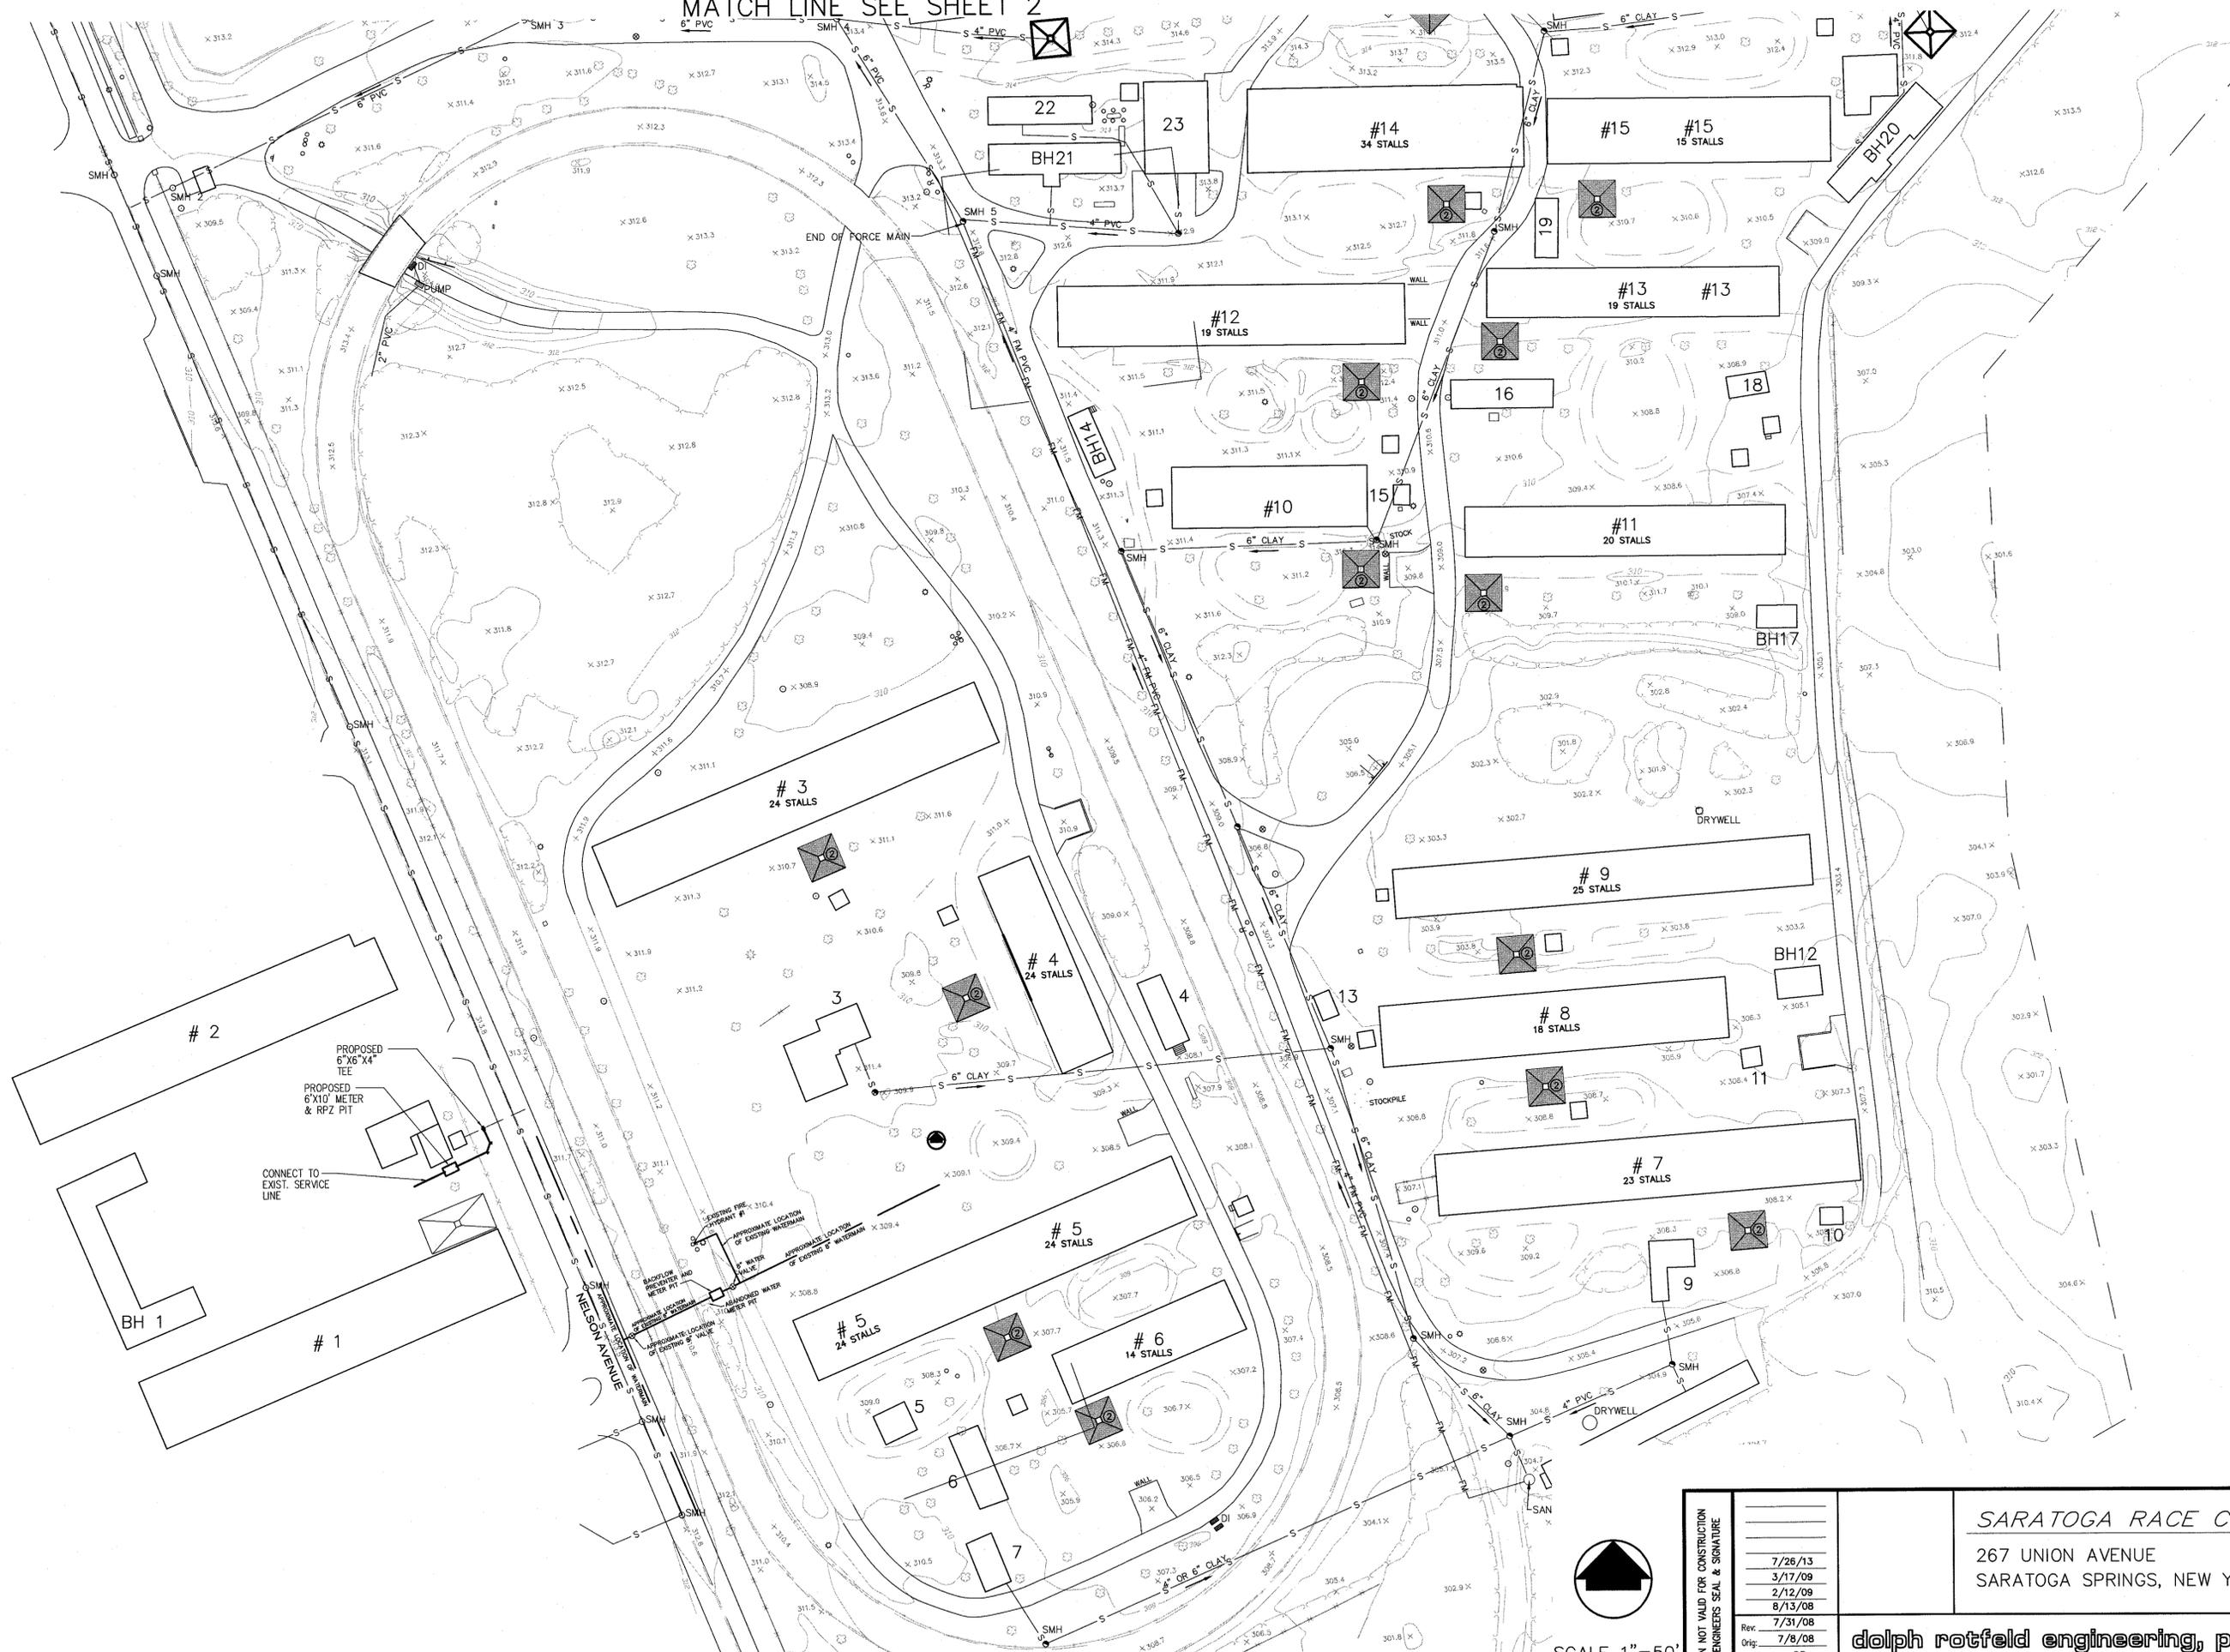
PROPOSED 6"x6"x4" TEL
 PROPOSED 6"x10" METER & RPZ PIT
 CONNECT TO EXIST. SERVICE LINE

EXISTING FIRE HYDRANT #1
 APPROXIMATE LOCATION OF EXISTING WATERMAIN
 APPROXIMATE LOCATION OF EXISTING WATERMAIN
 APPROXIMATE LOCATION OF EXISTING WATERMAIN

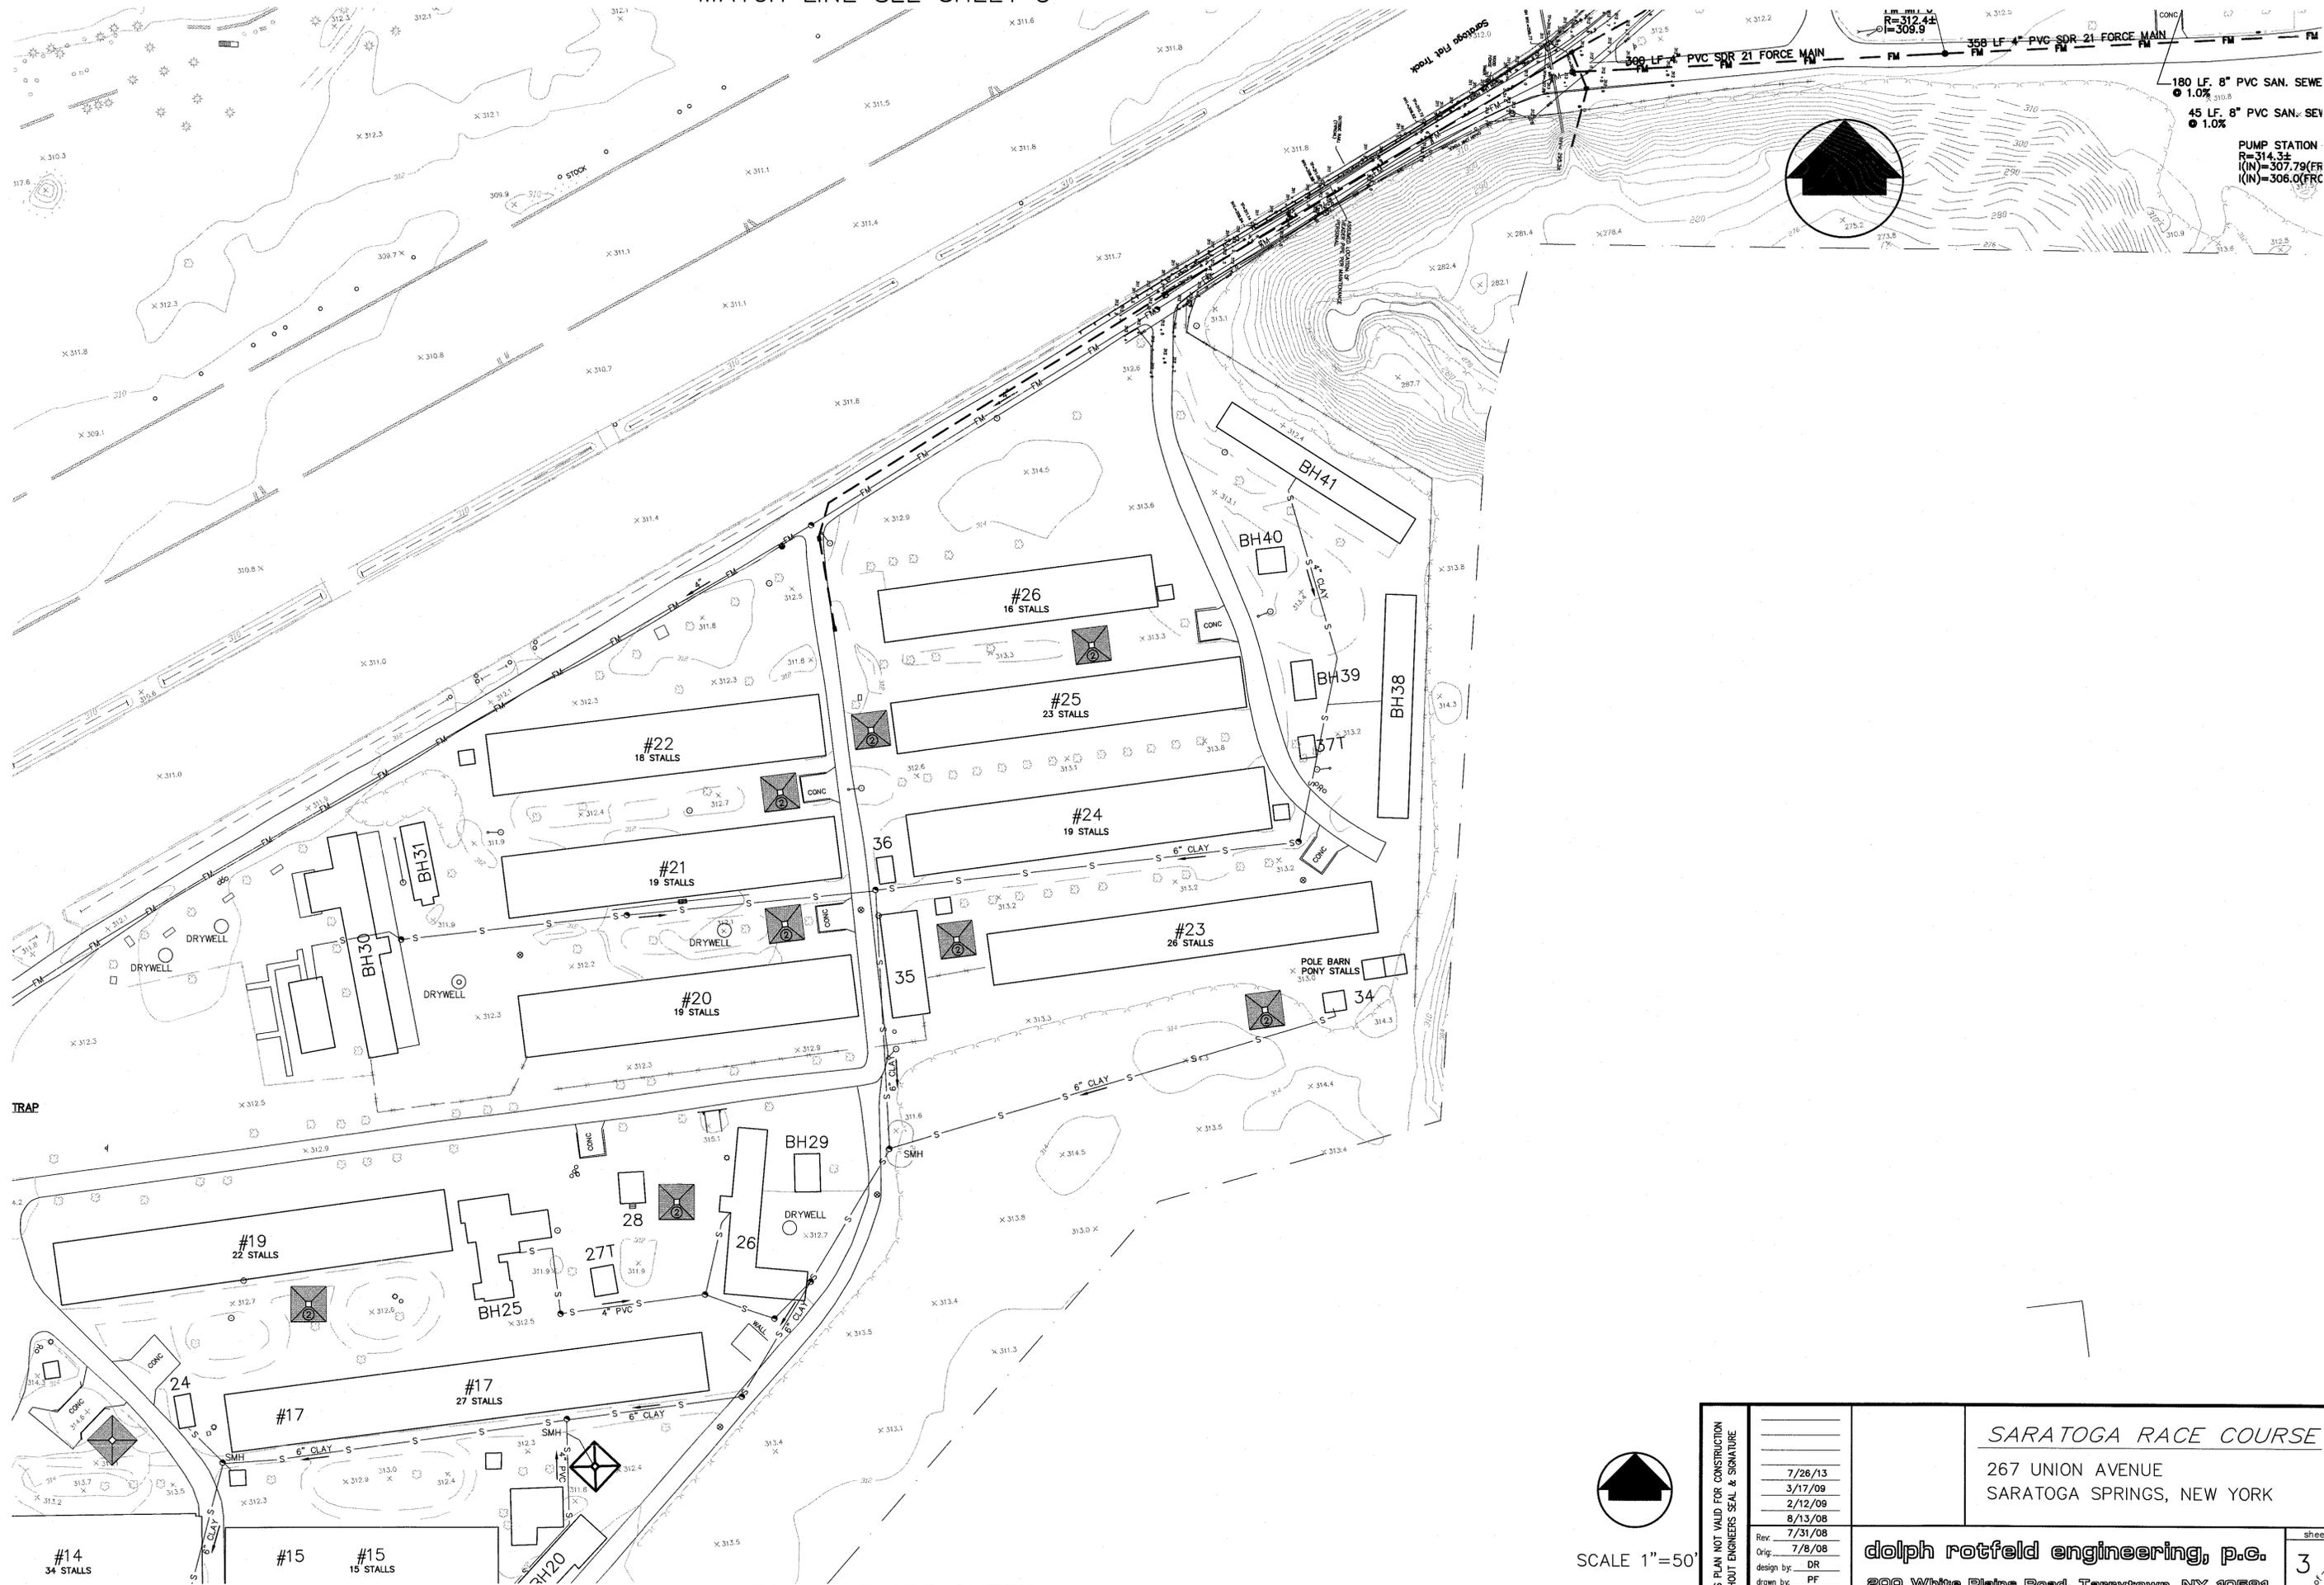
180 LF. 8" PVC SAN. SEWE
 @ 1.0%
 45 LF. 8" PVC SAN. SEW
 @ 1.0%

PUMP STATION
 R=314.3±
 I(N)=307.79(FR)
 I(N)=306.0(FRC)
